American Home Inspections of NE NC

Page 1 of 23
Unit #46010A

Property Address US Coast Guard Housing, Unit #46010A Kinnakeet Rd

Client Name U S Coast Guard

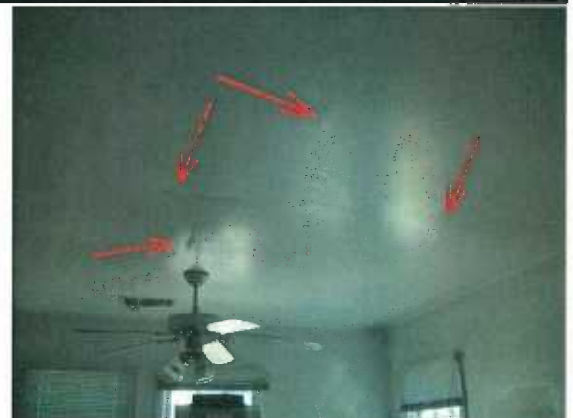
8. ☒ ☐ ☐ ☐ ☐ Closet: Single
9. ☐ ☐ ☐ ☐ ☒ Ceiling: Drywall There are cracks in the drywall ceiling. the cracks appear to follow the edges of the sheets of drywall. Also, the ceiling drywall appears to be bowing down in places.

14. Main Level Living Area Living Space Ceiling: Drywall There are cracks in the drywall ceiling. the cracks appear to follow the edges of the sheets of drywall. Also, the ceiling drywall appears to be bowing down in places.

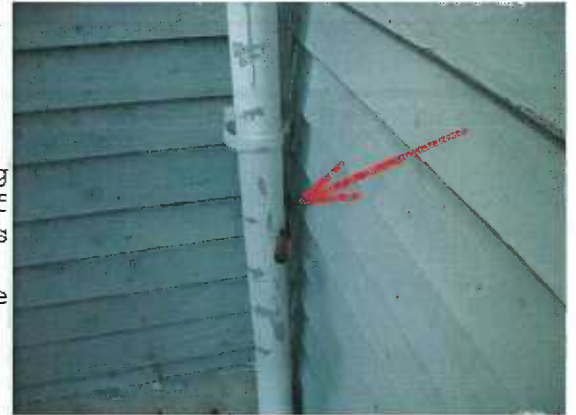
1. ☐ ☐ ☐ ☐ ☒ Type: Horizontal Wood Ship Lap Siding At the rear wall where the two units are joined, the siding is deteriorated. This is possibly caused by the way the hip roofs of the two duplex units meet in this area. There is no roof overhang on any of the roofs. During periods of rain, where the angles of the hip roofs meet, there is more rain water present than the gutters can drain, causing the gutters to overflow and allowing water migrating behind the siding into the house framing. The wood lap siding, the nails are backing out of the wood. The finish on the siding is peeling and fading. The wood lap siding should be re nailed, pressure washed and repainted.

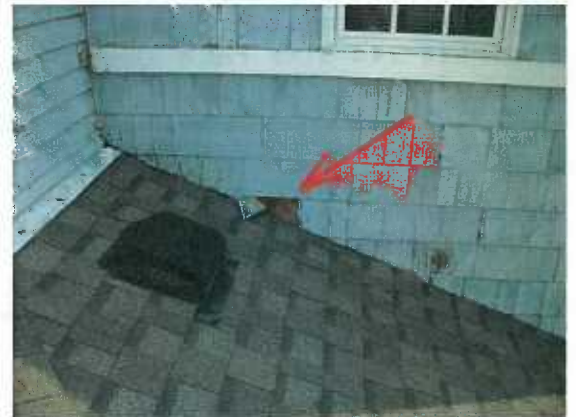
2. ☐ ☐ ☐ ☐ ☒ Type: Plywood Panels with machine shake appearance. The plywood siding in this area is deteriorated and should be replaced.

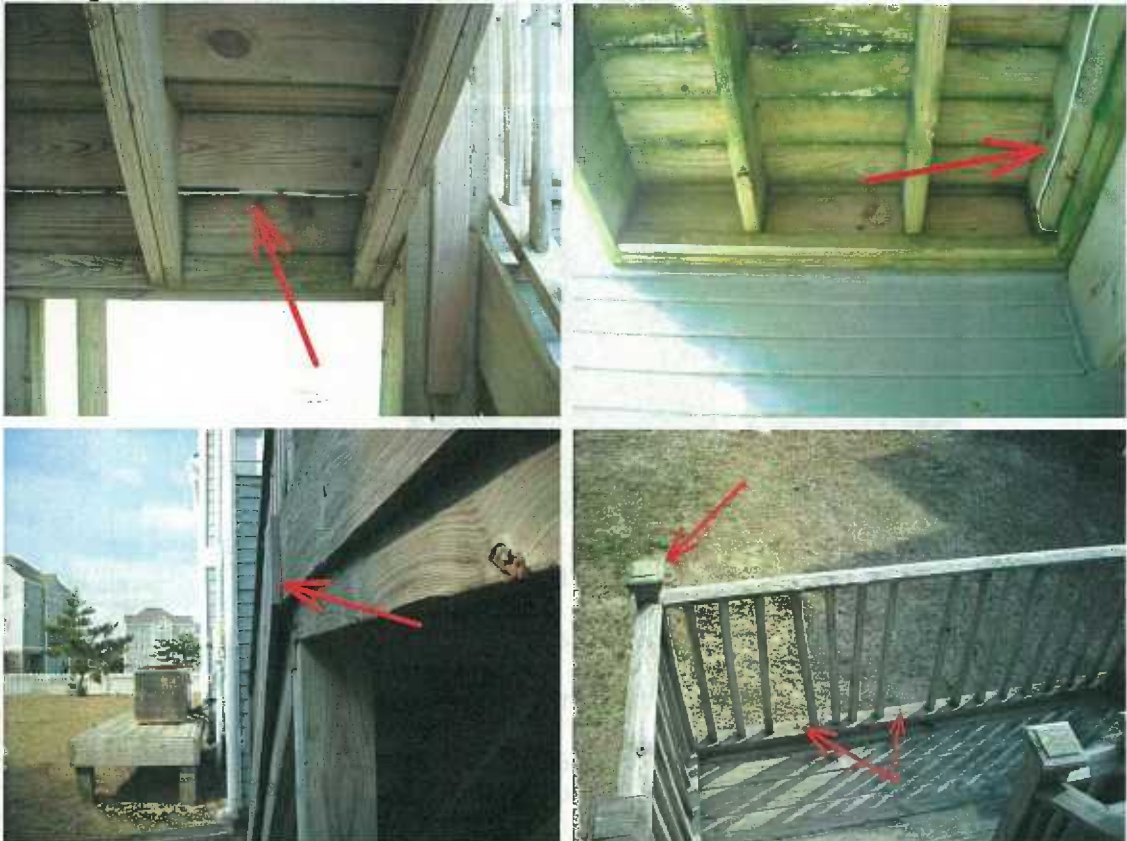
6. ☐ ☐ ☐ ☒ ☐ **Stairs & Landing:** All, Pressure Treated Wood There is a romex wire installed under the stairs to feed a light on the stair landing. This romex wire should have been installed in electrical conduit. The "beauty band on the side of the stairs has become loose and should be re nailed. Several of the handrail pickets have become loose, the nails holding the pickets in place are also deteriorated. The construction detail of the stair and landing handrails is faulty. The 2X4 boards used should have been installed with the edge side up not the flat side up. This make the handrail stronger and provides a better area to attach the wood pickets.

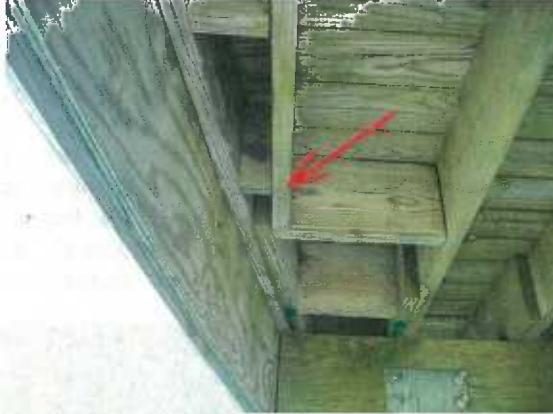
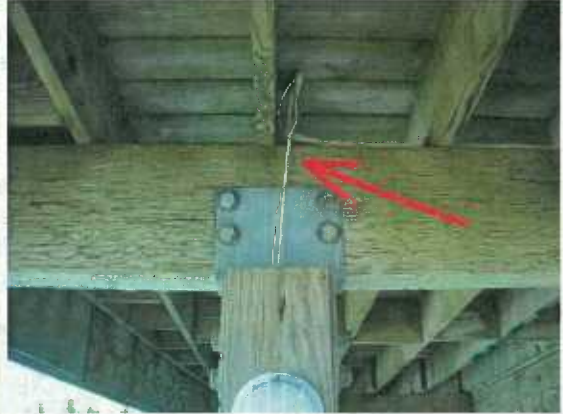
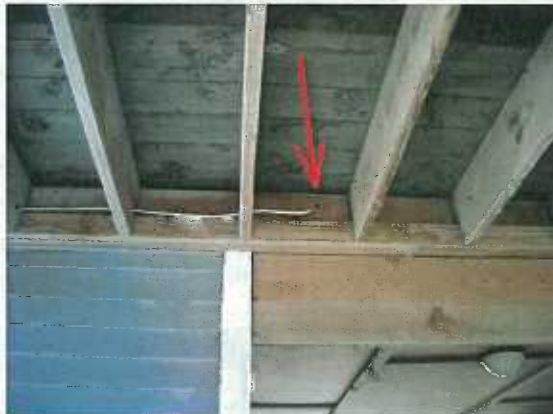
7. ☐ ☐ ☐ ☒ ☐ **Decks:** All, Pressure Treated Wood One floor joist at the front of the deck, the joist is held in place by the shear of the nails. It should have been installed in a metal joist hanger. There is a romex wire installed for a exterior light under the deck. This wire should have been installed in electrical conduit. The same romex wire, at the point where it enters the deck ledger against the house, the hole should have been filled with a sealed to keep moisture and insects out of the house.

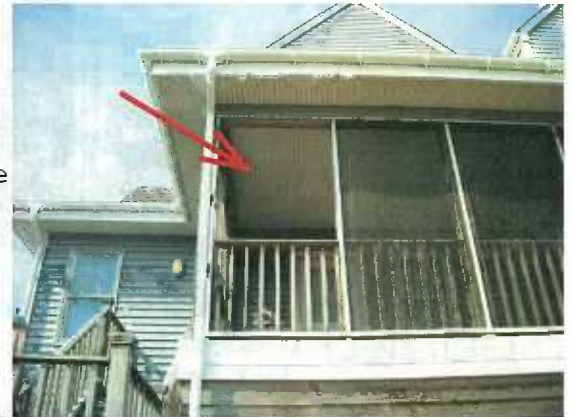
8. ☐ ☐ ☐ ☐ ☒ Porch: All, Pressure Treated Wood There are holes in the porch floor ledger board against the house that should be sealed to keep insects and moisture out. The porch lights did not respond to the switch. The porch exterior outlet did not respond to the testing device. The screen panels, one of the screens is missing. I would recommend that all the screens be removed from the porches. In this area with the high winds, maintaining screen porches is an ongoing problem.

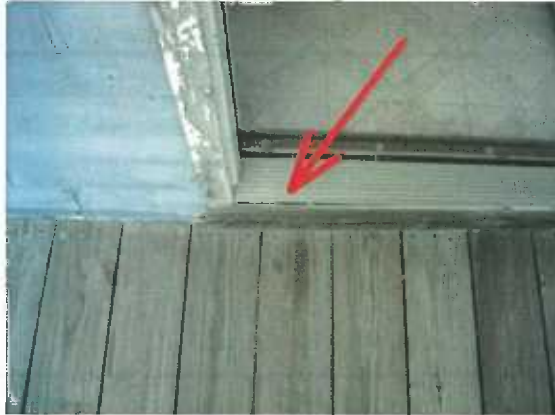
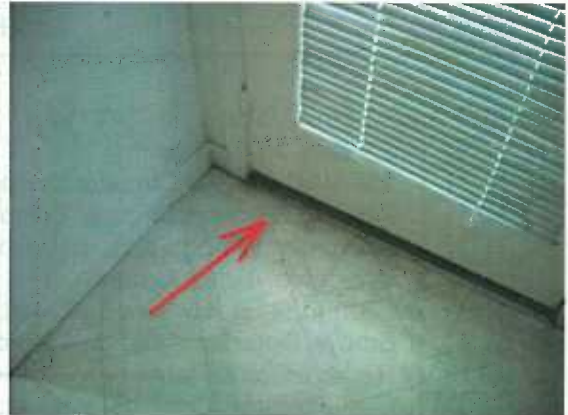
12. ☐ ☐ ☐ ☒ ☐ Entry Door: Kitchen/Dining Area, Fiberglass, Fullview Glass The wood sill support under the exterior door threshold should be removed and reinstalled properly under the door threshold. The vinyl flooring on the inside of the door is discolored. This is a clear indication that moisture is migrating under the bottom of the door and into the living area. The door should be adjusted to fit into the opening properly.

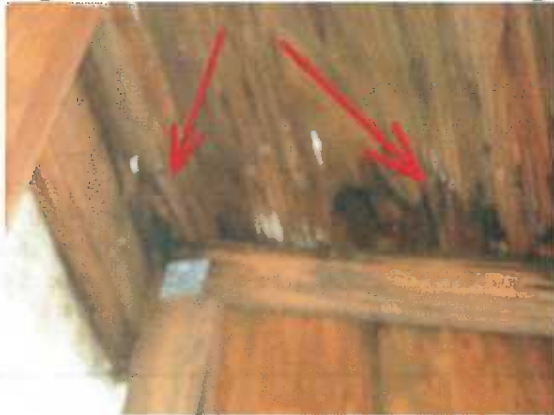
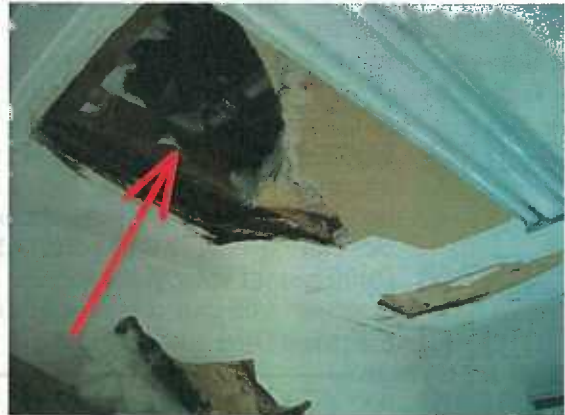
4. ☐ ☐ ☐ ☐ ☒ ☐ Ventilation: Roof and soffit vents The roof at the front right corner of the unit, the roof vent appears to be defective allowing moisture to enter the enclosed attic area. Also the roof gutter down spout is missing from the gutter installed above this roof. If this roof vent were eliminated, the problem would be solved.

Also, when the powder room ventilation fan was installed, the vent pipe was terminated under the roof vent in question. It appears that moisture is entering the vent pipe and running over to the ceiling bath fan, causing damage in that area.

It appears to me that the roof has been repaired since my first visit to the site but, the deteriorated truss roof and roof sheathing was not repaired before the roof was repaired.

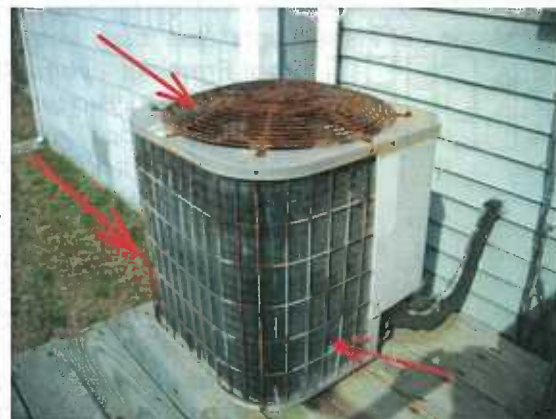
1. ☐ ☐ ☐ ☐ ☒ A/C System Operation: Inoperative The HVAC condenser is in a deteriorated state, the aluminum fins are falling from the copper coil, the metal parts of the cabinet and the interior parts are rusty and deteriorated. The condenser appears to be beyond economical repair.

8. ☐ ☐ ☐ ☐ ☒ Visible Coil: Copper core with aluminum fins As noted above, the aluminum fins on the copper coil are deteriorated and falling from the copper coil. The aluminum fins are intended to dissipate heat away from the copper coil. Without the aluminum fins, the condenser will over heat.

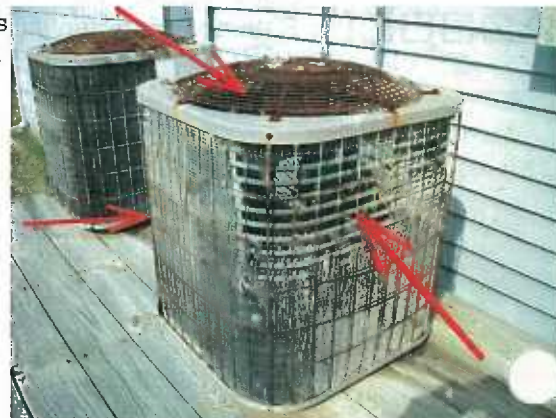
18. ☐ ☐ ☐ ☐ ☒ Visible Coil: Copper core with aluminum fins
Please see note above for Visible Coil.

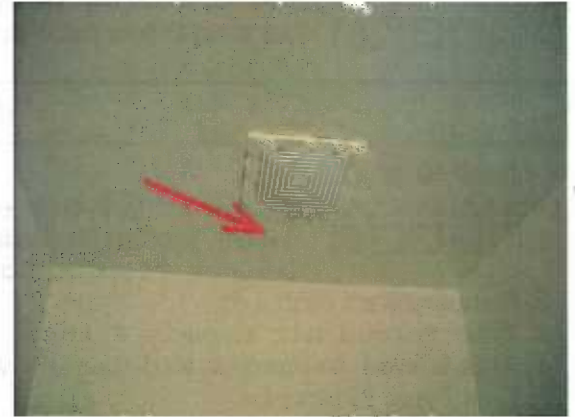
1. ☐ ☐ ☐ ☐ ☒ Ceiling: Drywall The drywall ceiling in the area of the exhaust fan is deteriorated from a roof leak.

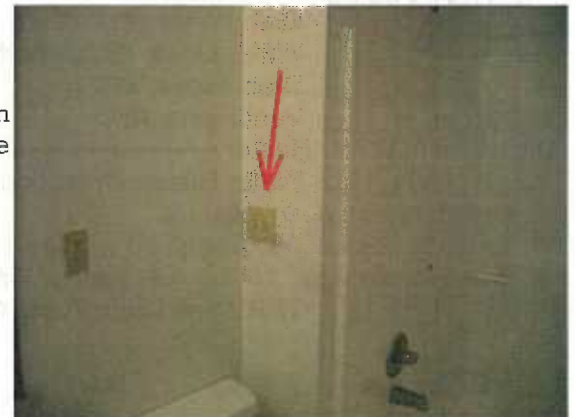
12. ☒ ☐ ☐ ☐ ☐ Ceiling: Drywall
 13. ☒ ☐ ☐ ☐ ☐ Walls: Drywall
 14. ☒ ☐ ☐ ☐ ☐ Floor: Vinyl floor covering
 15. ☒ ☐ ☐ ☐ ☐ Doors: Painted, Flush Solid Core
 16. ☐ ☐ ☐ ☒ ☐ Electrical: Light & Receptacle The wall mounted electrical switches for the exhaust fan and overhead light are within the reach of someone standing in the tub. There is not much that can be done at this point but, this is a safety issue.

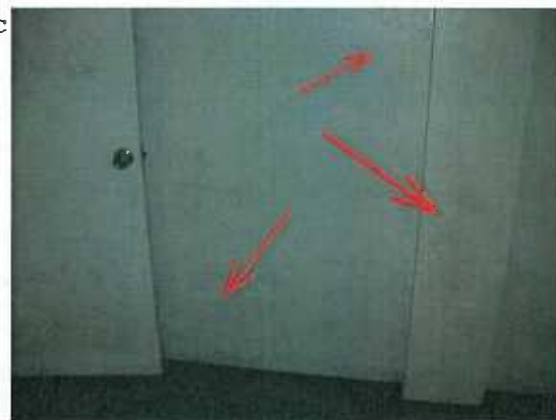
| 2. | <input type="checkbox"/> | <input type="checkbox"/> | <input type="checkbox"/> | <input checked="" type="checkbox"/> | <input type="checkbox"/> | Walls: Paneling, Painted There is organic growth present in many places on the walls. |

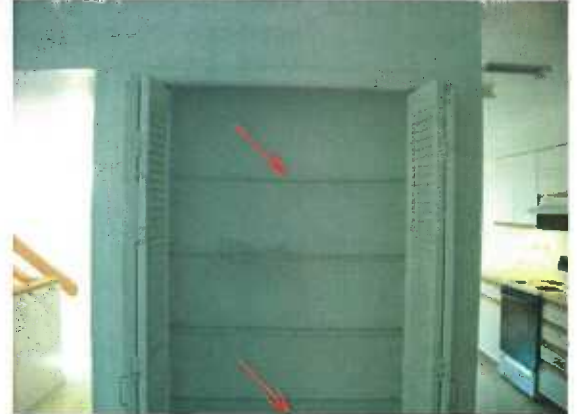
8. ☐ ☐ ☐ ☒ ☐ Closet: Single Wire shelves, the center support is missing from the shelves, causing the shelves to be bent in the center.

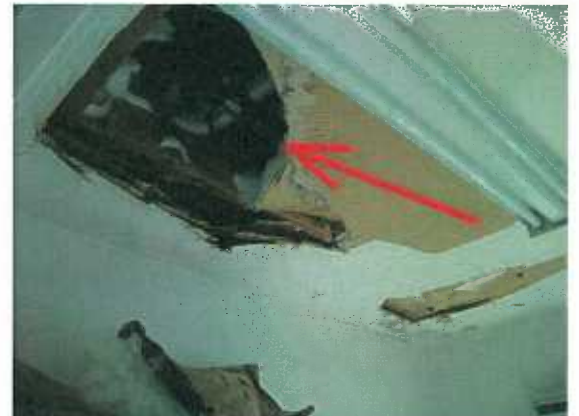
1. ☐ ☐ ☐ ☐ ☒ Ceiling: Drywall The drywall ceiling is damaged from a roof leak above.

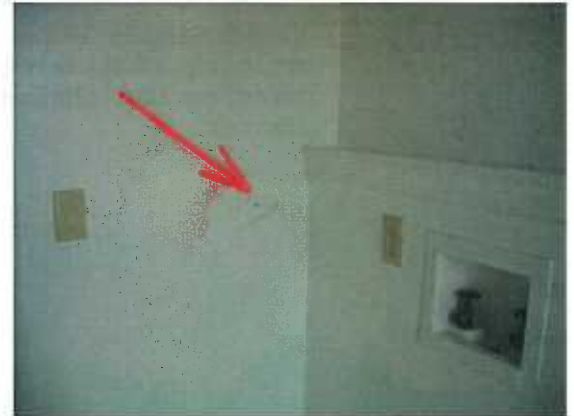
2. ☒ ☐ ☐ ☐ ☐ Walls: Drywall The drywall in the corner appears to be damaged from the same roof leak.

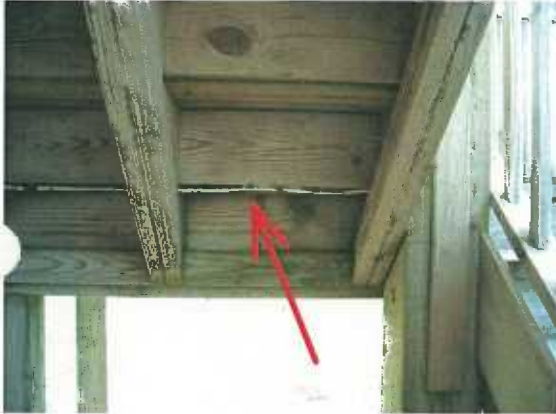
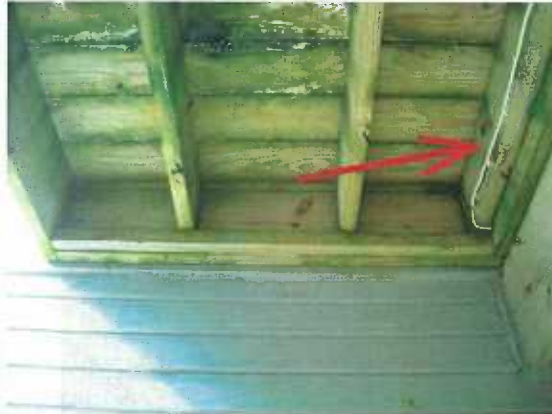
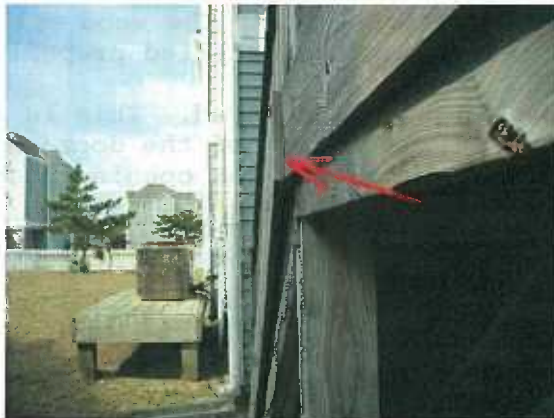
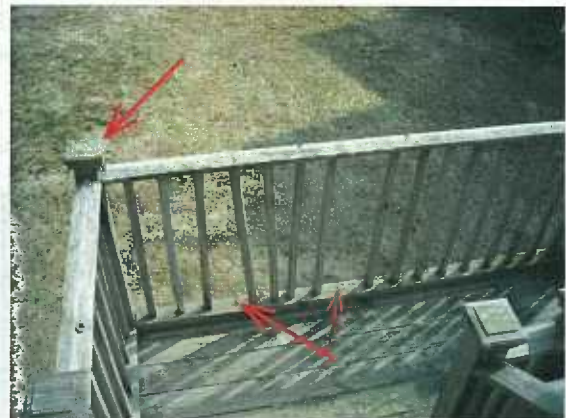
1. **Stairs & Landing:** All, Pressure Treated Wood There is a romex wire installed under the stairs to feed a light on the stair landing. This romex wire should have been installed in electrical conduit. The "beauty band" on the side of the stairs has become loose and should be re nailed.

Several of the handrail pickets have become loose, the nails holding the pickets in place are also deteriorated. The construction detail of the stair and landing handrails is faulty. The 2X4 boards used should have been installed with the edge side up not the flat side up. This makes the handrail stronger and provides a better area to attach the wood pickets.

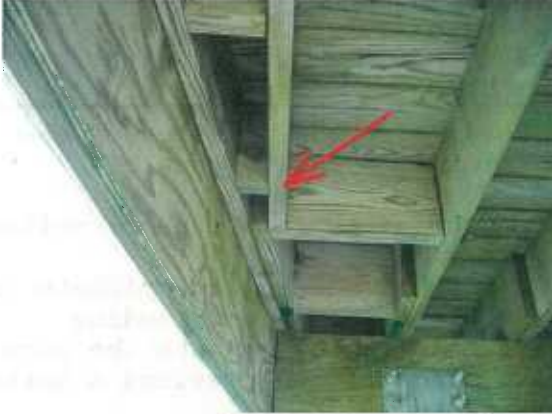
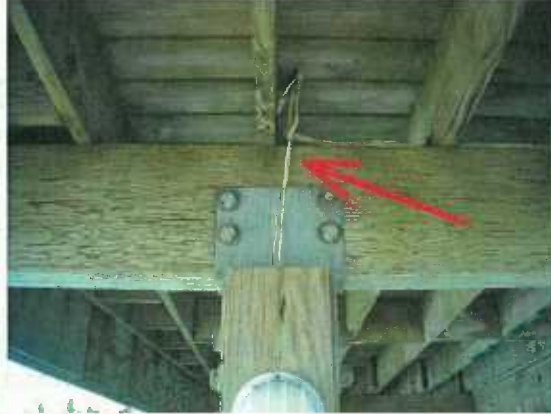
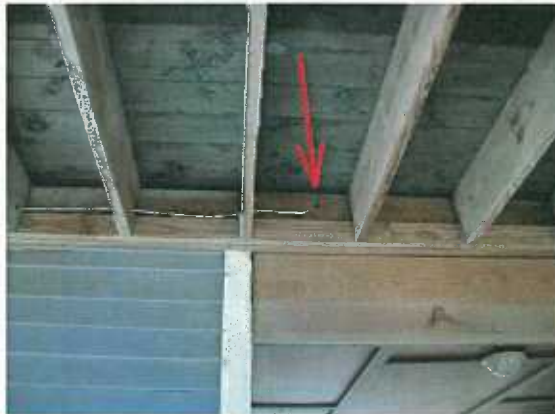
2. **Decks:** All, Pressure Treated Wood One floor joist at the front of the deck, the joist is held in place by the shear of the nails. It should have been installed in a metal joist hanger. There is a romex wire installed for an exterior light under the deck. This wire should have been installed in electrical conduit. The same romex wire, at the point where it enters the deck ledger against the house, the hole should have been filled with a sealant to keep moisture and insects out of the house.

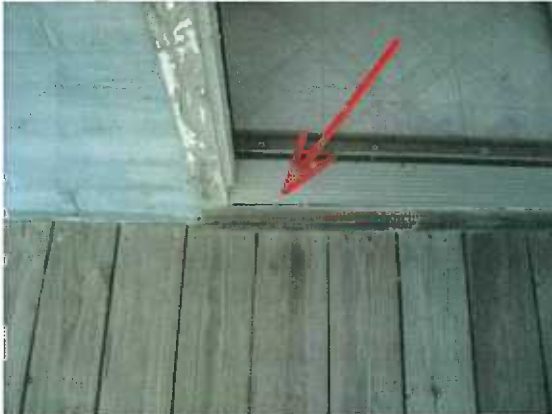
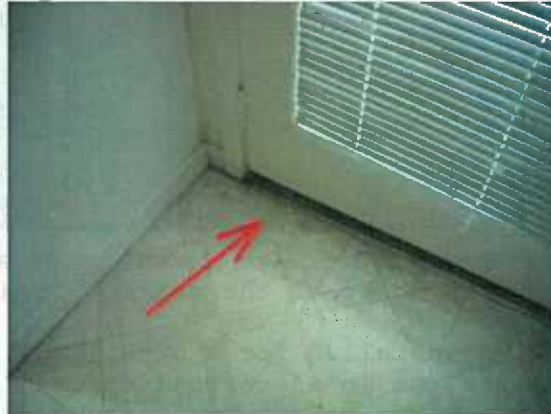
3. Entry Door: Kitchen/Dining Area, Fiberglass, Fullview Glass The wood sill support under the exterior door threshold should be removed and reinstalled properly under the door threshold.

The vinyl flooring on the inside of the door is discolored. This is a clear indication that moisture is migrating under the bottom of the door and into the living area. The door should be adjusted to fit into the opening properly.

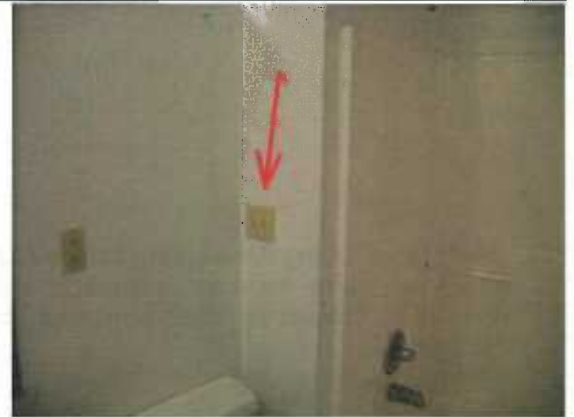
7. Top Floor Bathroom Electrical: Light & Receptacle The wall mounted electrical switches for the exhaust fan and overhead light are within the reach of someone standing in the tub. There is not much that can be done at this point but, this is a safety issue.

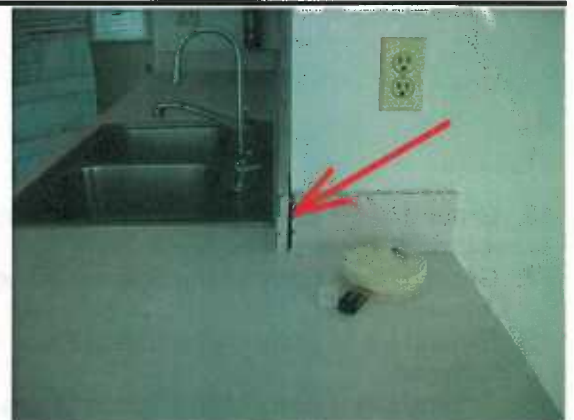
8. Kitchen & Dining Area, Main Level Kitchen Counter Tops: Laminate and composite materials The counter top back splash is separating from the wall.

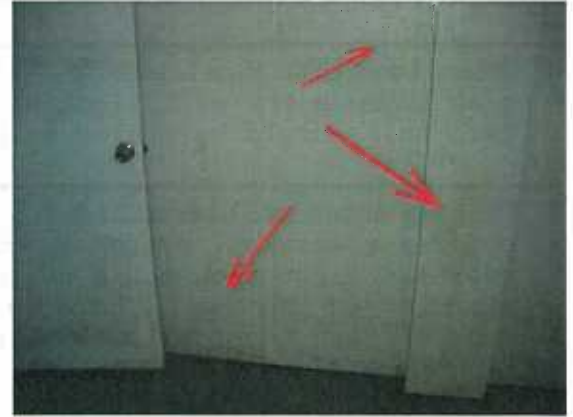
11. Ground Level Utility/Storage Room Living Space Walls: Paneling, Painted There is organic growth present in many places on the walls.

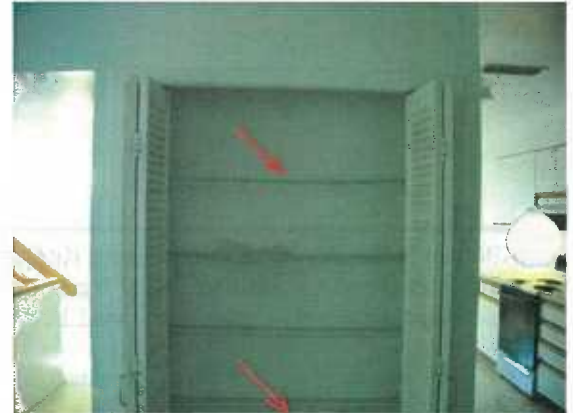
12. Main Level Living Area Living Space Closet: Single Wire shelves, the center support is missing from the shelves, causing the shelves to be bent in the center.

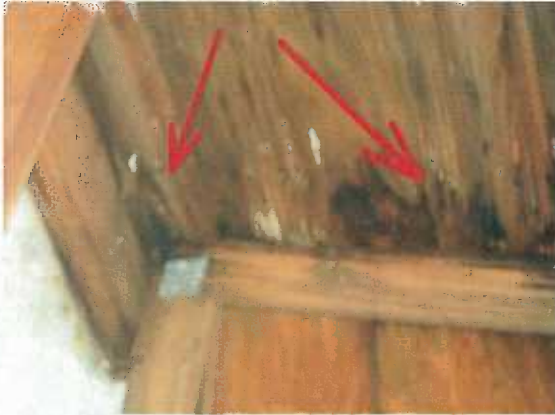
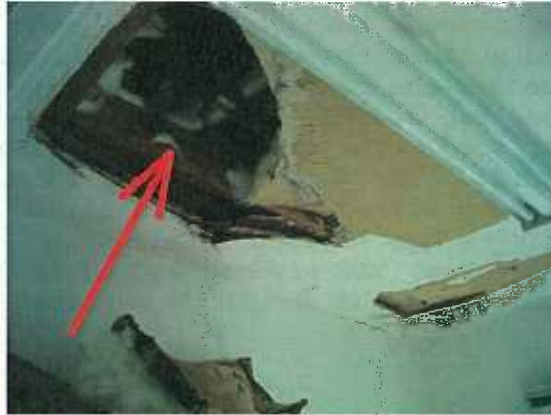
5. **Main Attic Ventilation:** Roof and soffit vents The roof at the front right corner of the unit, the roof vent appears to be defective allowing moisture to enter the enclosed attic area. Also the roof gutter down spout is missing from the gutter installed above this roof. If this roof vent were eliminated, the problem would be solved. Also, when the powder room ventilation fan was installed, the vent pipe was terminated under the roof vent in question. It appears that moisture is entering the vent pipe and running over to the ceiling bath fan, causing damage in that area. It appears to me that the roof has been repaired since my first visit to the site but, the deteriorated truss roof and roof sheathing was not repaired before the roof was repaired.

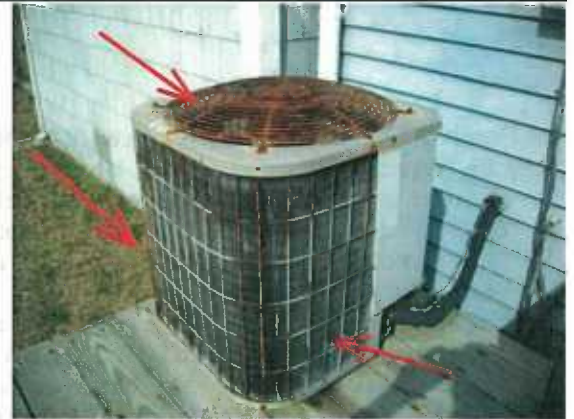
7. **South Side AC System A/C System Operation:** Inoperative The HVAC condenser is in a deteriorated state, the aluminum fins are falling from the copper coil, the metal parts of the cabinet and the interior parts are rusty and deteriorated. The condenser appears to be beyond economical repair.

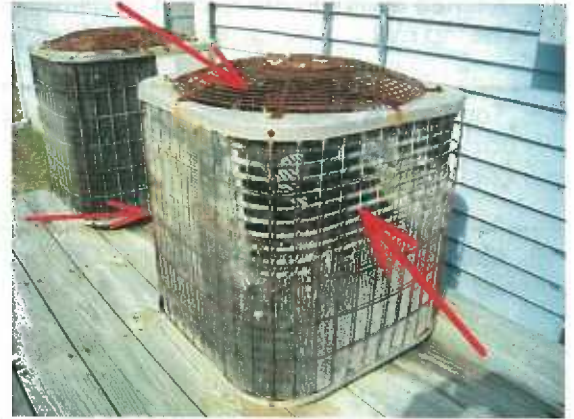
11. South Side AC System Visible Coil: Copper core with aluminum fins Please see note above for Visible Coil.

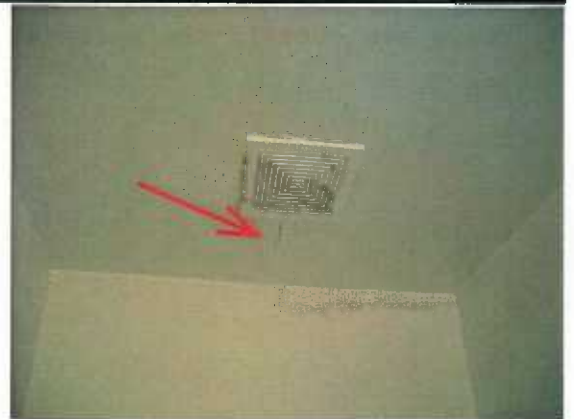
- Main Level Powder Room Bathroom Ceiling: Drywall The drywall ceiling in the area of the exhaust fan is deteriorated from a roof leak.

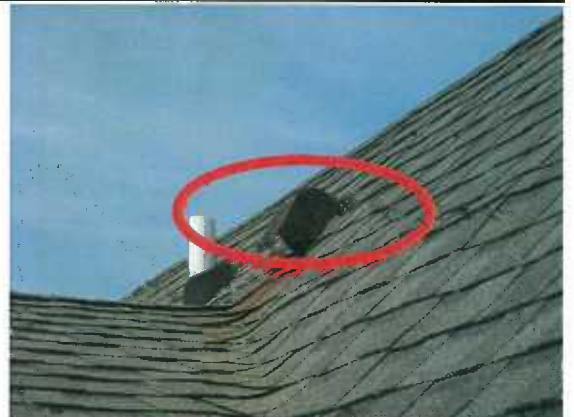
1. ☒ ☐ ☐ ☐ ☐ Cooking Appliances: General Electric
2. ☐ ☐ ☐ ☐ ☒ Ventilator: General Electric The roof termination cover for the range ventilation fan is deteriorated.

16. Kitchen & Dining Area, Main Level Kitchen Ventilator: General Electric The roof termination cover for the range ventilation fan is deteriorated.

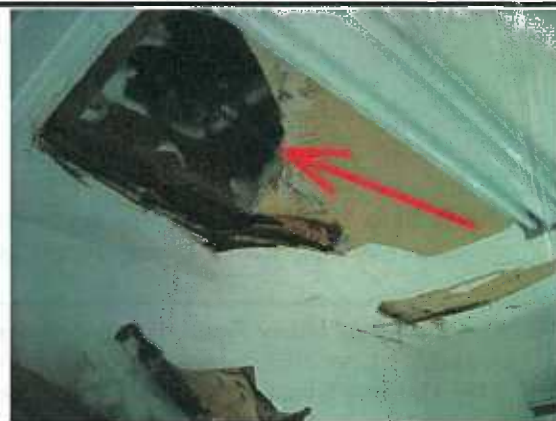
19. Main Level Laundry Room/Area Ceiling: Drywall The drywall ceiling is damaged from a roof leak above.
